# RAPID DEPRESSURIZATION

An oxygen cylinder burst and tore a hole through the fuselage of a 747.

BY MARK LACAGNINA

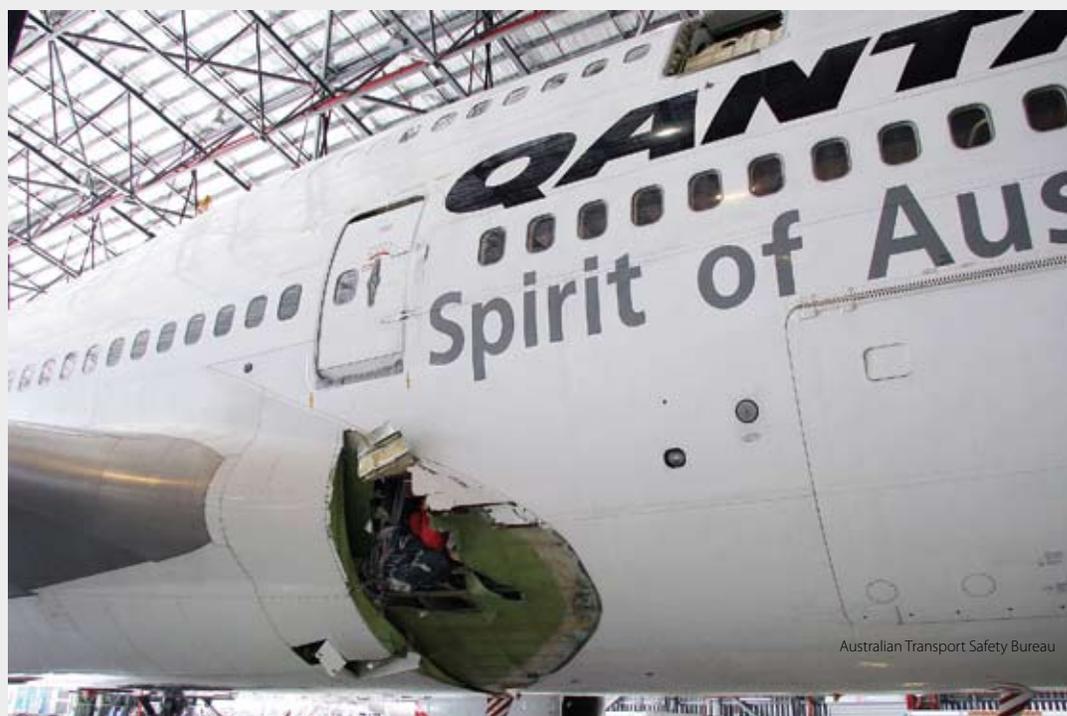
The accident aircraft (above) received substantial damage to its fuselage and other exterior and interior components when the cylinder burst.

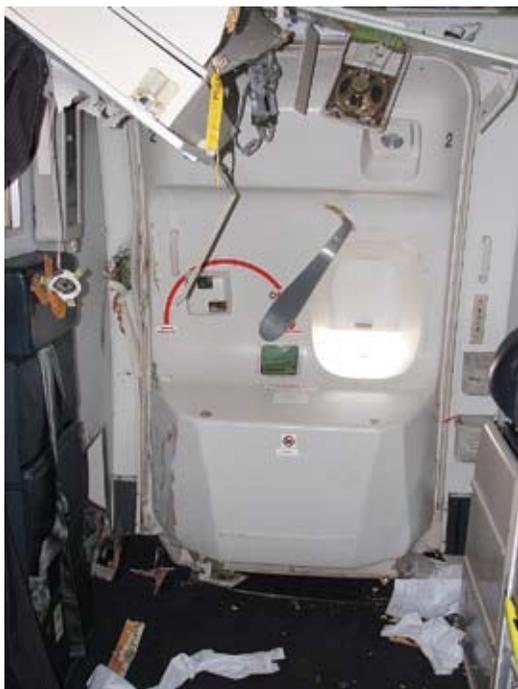
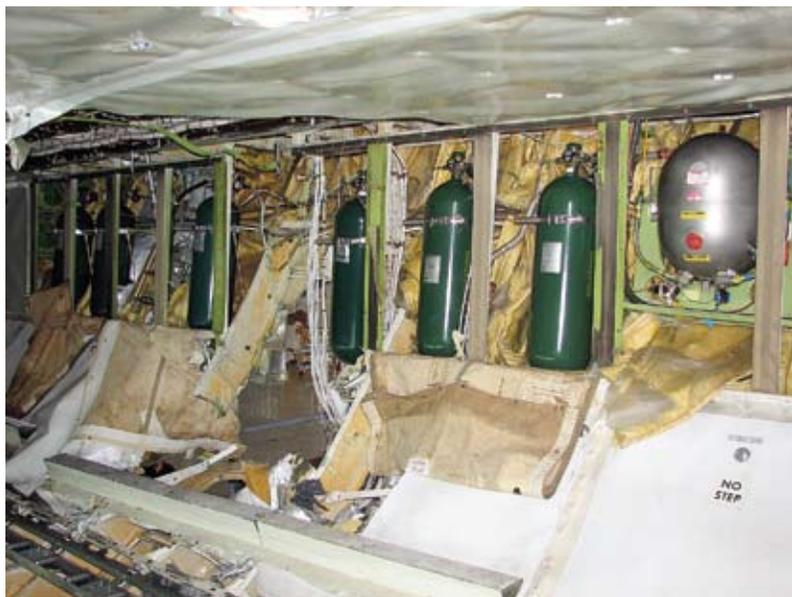
The explosion ripped open the forward cargo hold and propelled the cylinder upward through the cabin floor, where it struck the door latch and overhead cabinets.

when the cylinder burst had torn a hole about 2.0 m (6.6 ft) high and 1.5 m (4.9 ft) wide, just forward of the right wing root. “Fuselage materials, wiring and cargo from the aircraft’s forward hold were protruding from the rupture,” the report said. The excess pressure created when the cylinder burst also opened the two pressure relief valve blowout doors on the left side of the cargo hold.

Although the cylinder itself was not recovered, the damage it caused enabled investigators to assemble a likely failure scenario. “It was evident that the cylinder had failed by bursting through or around the base, allowing the release of pressurized contents to project it vertically upward,” the report said. The cylinder severed 85 electrical wires and the first officer’s aileron control cables<sup>1</sup> before it penetrated the cabin floor, struck the R2 door frame and smashed the overhead paneling and storage cabinets. Investigators believe the cylinder then dropped back through the hole in the cabin floor and was swept out of the aircraft through the tear in the fuselage.
